Strategic Facilities Planning Study

January 2016

City of Fitchburg
MASSACHUSETTS

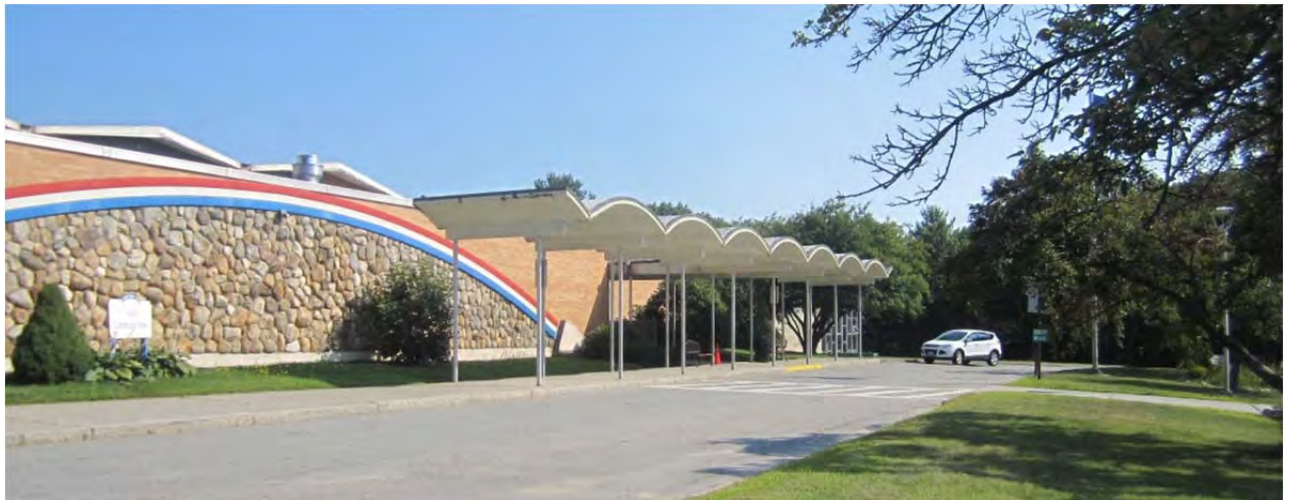
SITE: Buses currently queue along the driveway next to the building. Parents queue in the parking lot parallel to the buses; this requires students to pass between parked buses. Parking capacity was described as inadequate and the bituminous concrete had numerous cracks. Drainage structures and curbs were not apparent. Three paved playground areas exist at the rear of the school; however they are not used for parking. Due to steep topography, only about 75% of the perimeter has Fire Department access to the building.

RATING: POOR

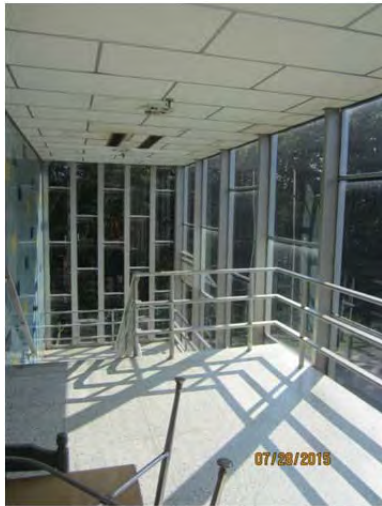
EXTERIOR ENVELOPE: Existing roofing is a single-ply low-slope membrane system and is designated for replacement in the District’s 2016 Capital Needs plan. Exposed glue-lam wood roof beam ends have, in places, begun to deteriorate from exposure to weather. Windows and storefront/entries are inefficient single-glazed aluminum; the stairs of the NE building in particular have a significant amount of glazing that allows extreme heat gain/loss depending on the season. Exterior walls are a combination of brick and stone masonry and likely have little to no insulation or air/vapor barrier.

RATING: POOR

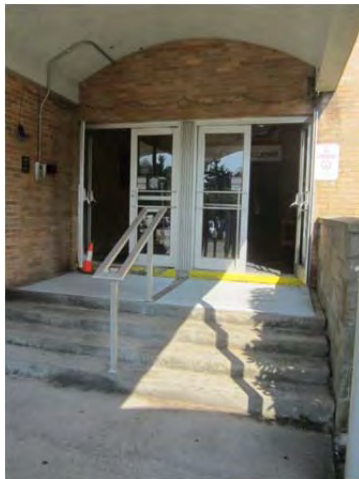
SECURITY AND ACCESS CONTROL: The main administration office is well-located to monitor the front entrance and is equipped with an intercom station (which presumably allows remote release of the main entry door during the school day). Video surveillance cameras were not observed. Status of District masterkey system is unknown.

RATING: FAIR

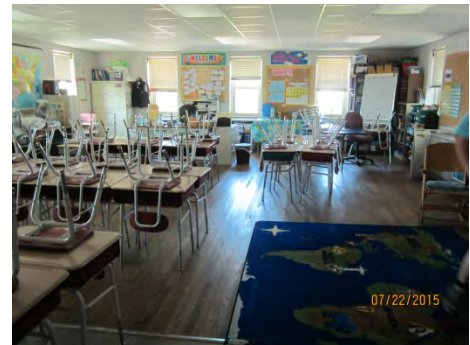
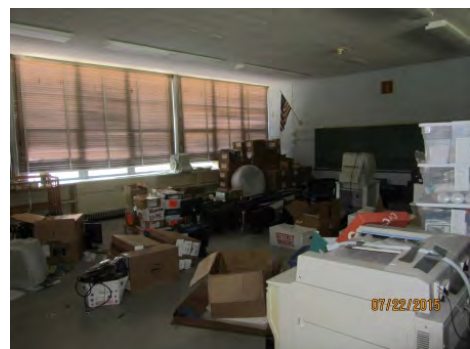
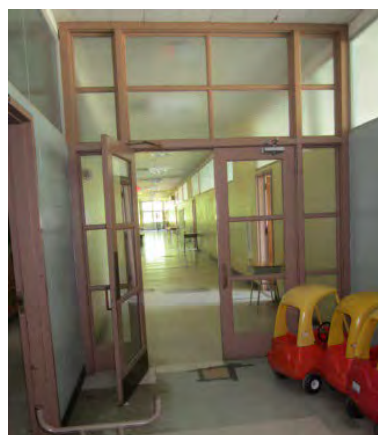
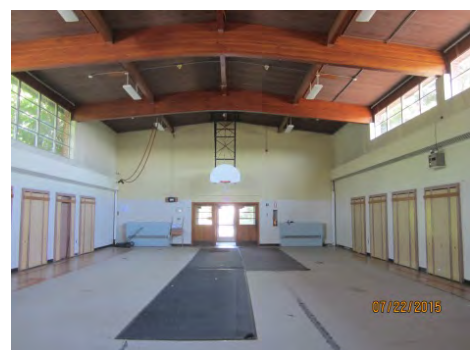
South Building: Classrooms typically have 9" x 9" VAT floor; resilient base; painted CMU walls; and 12" x 12" ACT ceilings. Corridors have terrazzo floor; resilient base; painted CMU walls; 12" x 12" ACT ceilings; and built-in cubbies. Toilet rooms have mosaic tile flooring; 4" x 4" glazed ceramic tile walls and base; and 2' x 2' ACT ceilings. Toilet partitions are painted steel; shower stall dividers at the former locker rooms are a combination of painted steel and marble. The Gymnasium has wood strip flooring; painted CMU walls and severely damaged 2' x 2' ACT ceiling.

RATING: FAIR

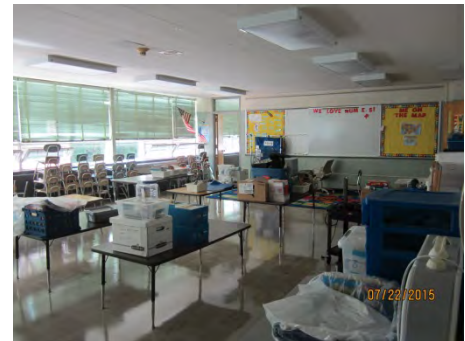
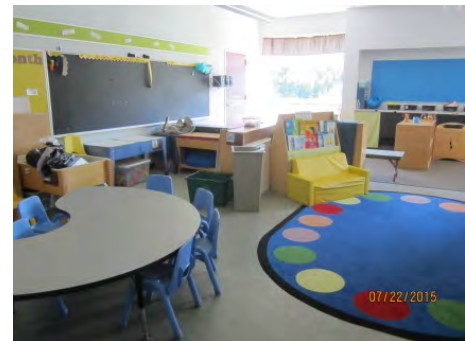
East Building: Classrooms typically have 12" x 12" VCT floor; resilient base; painted walls; and 2' x 2' ACT ceilings. Corridors have 12" x 12" VCT flooring; resilient base; painted walls; and 2' x 2' ACT ceilings. Toilet rooms have 2" x 2" mosaic tile floor; 4" x 4" glazed ceramic tile walls and base; and 2' x 2' ACT ceilings.

RATING: FAIR

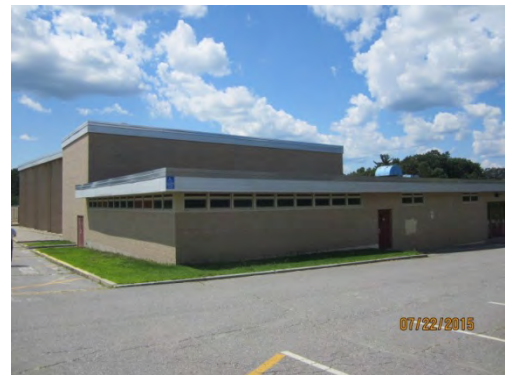
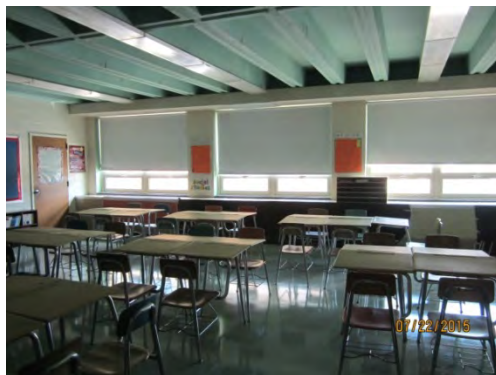
INTERIOR FINISHES/EQUIPMENT: Classrooms typically have 9" x 9" vinyl asbestos tile (VAT) flooring with glazed CMU base, painted CMU walls, and either 2' x 4' ACT, exposed concrete structure (at lower level), or exposed glue-lam beam and wood deck roof structure (at first floor). Corridors are treated the same as classrooms. Stairs have resilient treads with painted steel risers, stringers and guards; painted CMU walls; and stained wood handrails. Toilet rooms have ceramic mosaic tile

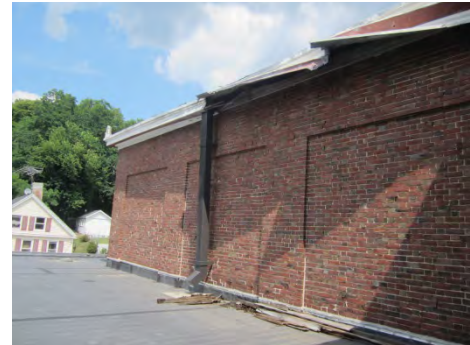
EXTERIOR ENVELOPE: The main building roofing is original slate with built-in gutters. Many slates are missing and the gutter linings have failed; it was reported that many leaks have developed and are causing wood framing to rot. We observed extensive rot at the wood fascias over the Auditorium. Gym and Auditorium roofing have low-slope single-ply membrane systems; their age is unknown however, given the reported number of leaks in the building, it can be assumed they are in need of replacement.

The Media Center addition roof is also a single-ply membrane system and, being 20+ years old, is approaching the end of its useable life expectancy. The original wood windows were replaced with metal or vinyl single-hung operable windows which reportedly have leaked.

RATING: POOR

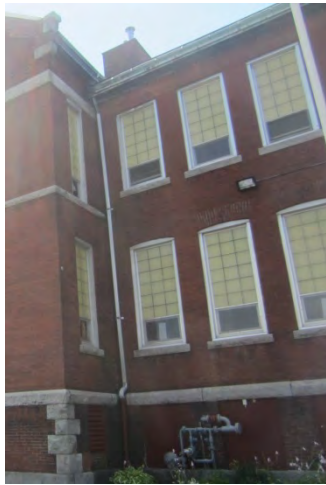
EXTERIOR ENVELOPE: Roofing consists of asphalt shingles with sheet metal flashings, gutters and downspouts. Original wood windows have been replaced over the years by a combination of single-glazed aluminum projected windows, glass block, and fixed translucent fiberglass panels. Exterior walls are brick masonry with granite details.
RATING: POOR
