FITCHBURG CITY HALL CAMPUS

City Council Presentation

17 December 2019

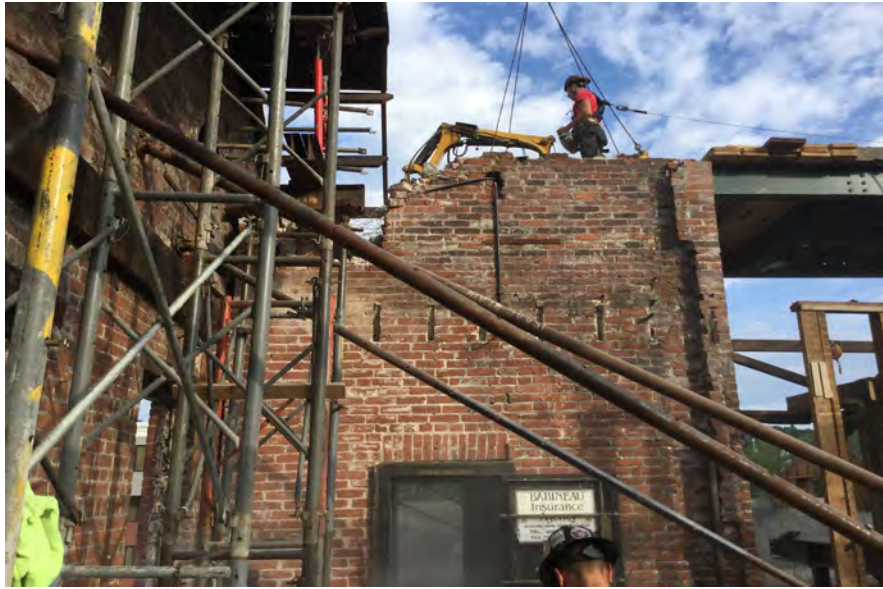
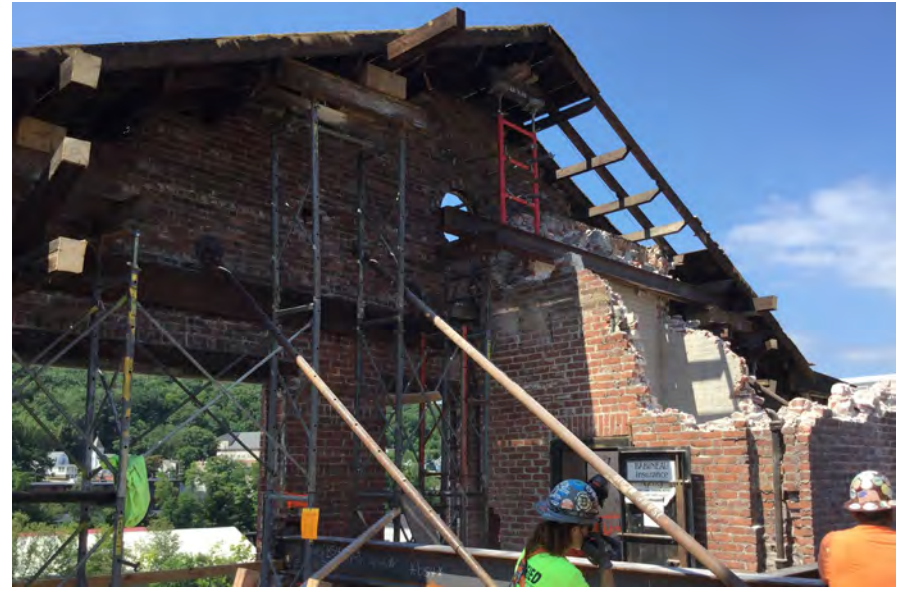
- Early coordination with Demolition and Steel contractors proved the need to keep existing floors in while other floors were built which was feasible due to difference in elevation.
- In doing this we were able to save on and limit the amount of temporary shoring needed to accommodate a renovation of this type and magnitude.
- Interior abatement and demolition of walls and ceilings was completed to allow new foundations and steel to proceed in both sections of the building.
- The focus was to build 1879 section top down with steel after foundations were completed which meant removing the roof 1st so new columns and roof could be installed along with upper level floors.
- We then had demolition begin top down following steel install.

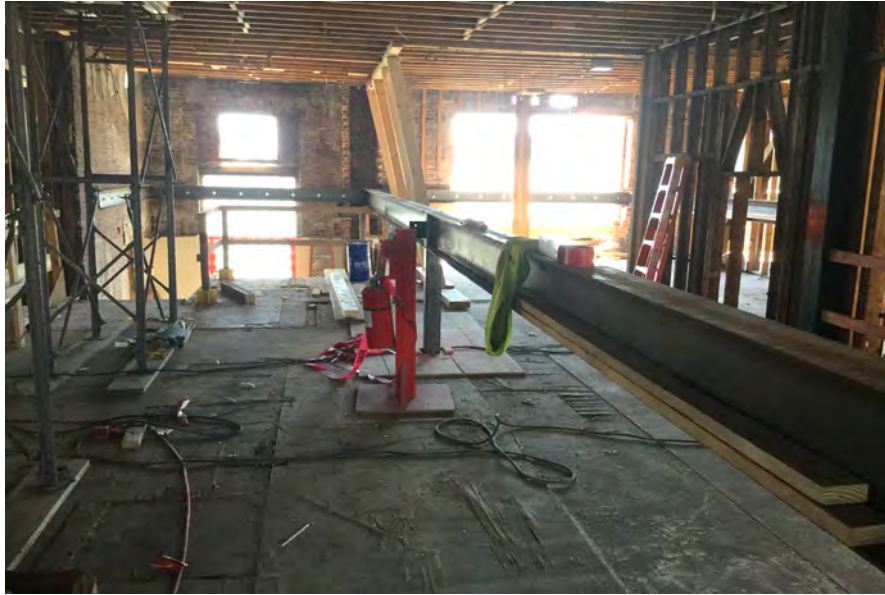
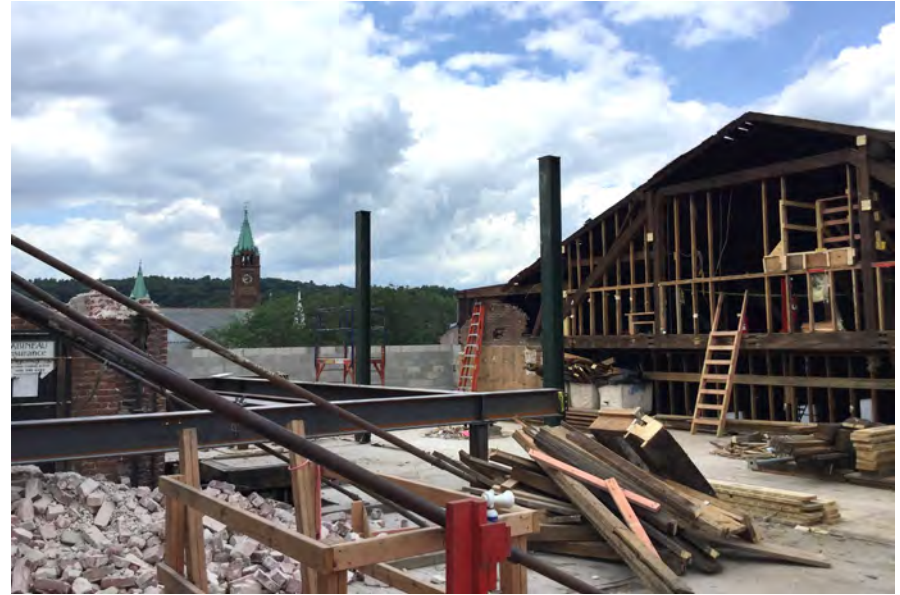
TEMPORARY SHORING PLAN

- Isaac Blair designed, and installed tower supports and struts to hold gable wall during demo and steel installation.
- Vaults at each floor hindered complete steel installation until after its complete removal down to basement.

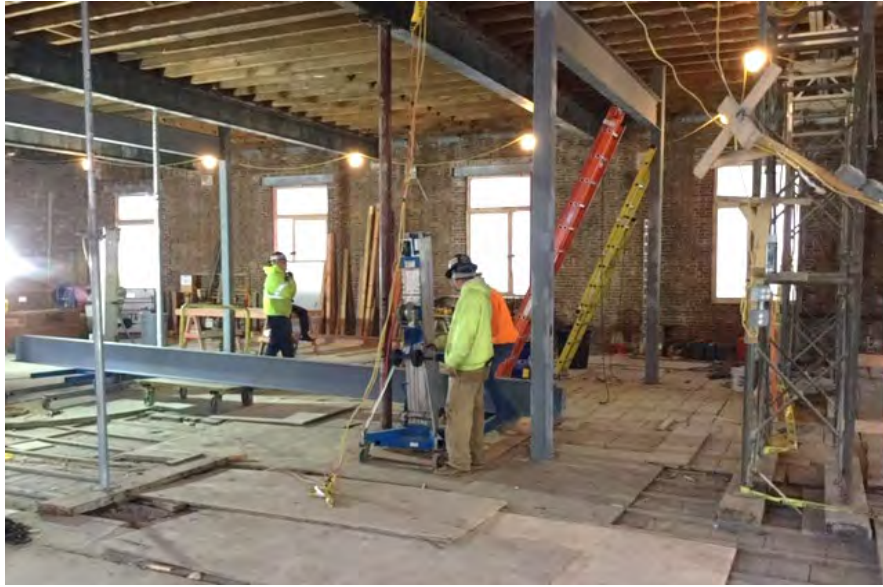
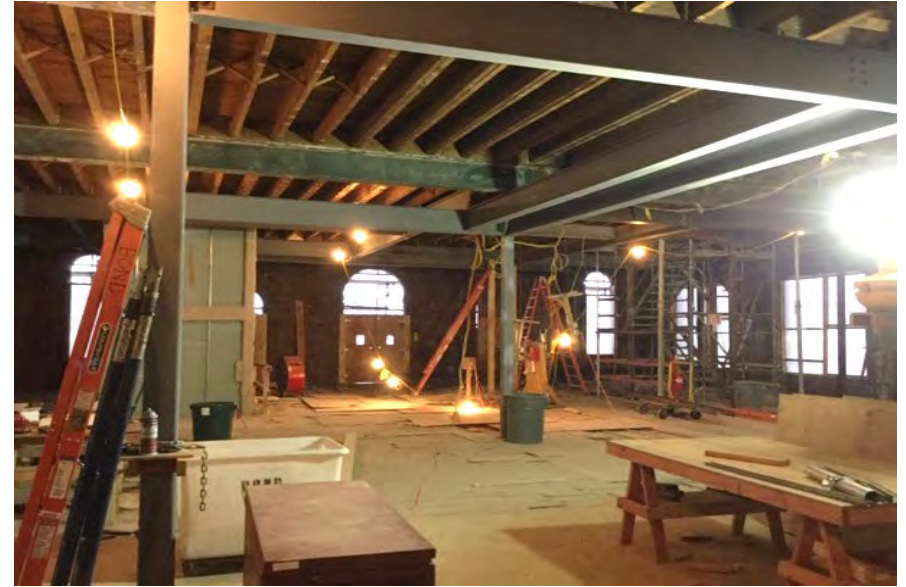
1853 STEEL INSTALL

- This is most challenging section of the steel install for sure as logistics around moving the heavier lengths is done by telescoping steel beams & columns through the scaffold and then wheeling on a-frames and genie lifts to hoist into place and weld connections.
- 2nd and 3rd floor frames are now completed as of 11/14. Detailing work is ongoing through this week and the subflooring is close behind completion of the steel.

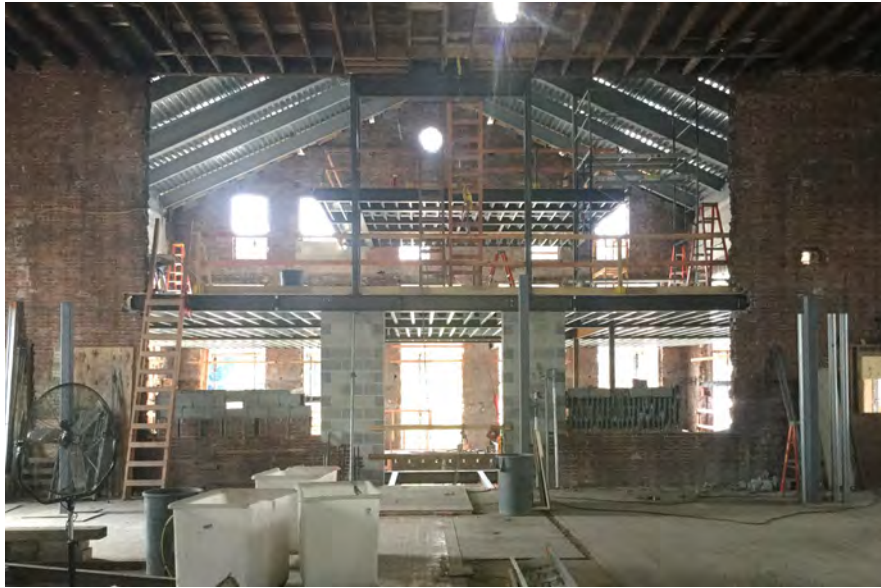
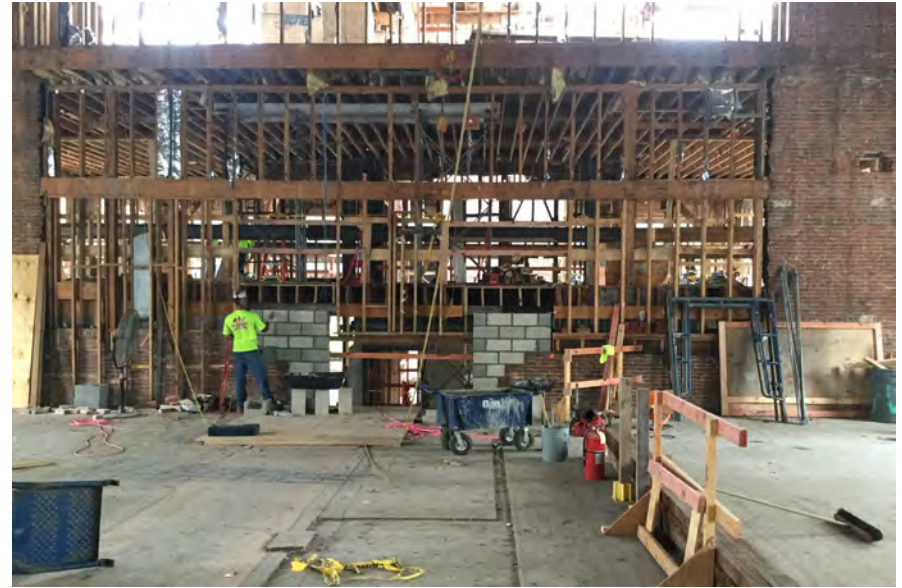
D LINE ROOF SUPPORT

- It was realized early in demolition that the shear wall thought to be at the old party wall location had been mostly removed in an early renovation to create a proscenium opening for what was a stage in the earlier life of the building.
- This caused redesign of structural elements that made up the roof support of the new 1879 section roof.

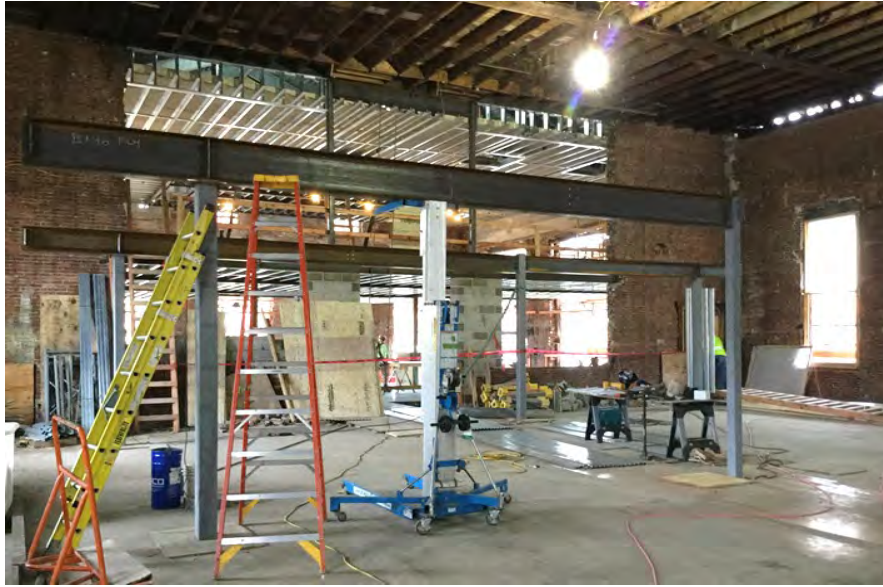
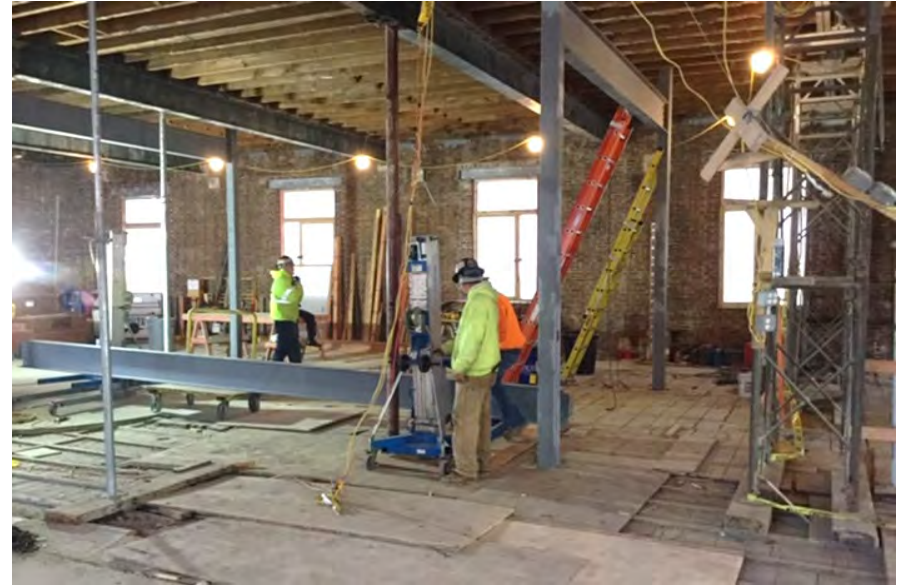
1853 STEEL INSTALL

- This is most challenging section of the steel install for sure as logistics around moving the heavier lengths is done by telescoping steel beams & columns through the scaffold and then wheeling on a-frames and genie lifts to hoist into place and weld connections.
- 2nd and 3rd floor frames are now completed as of 11/14. Detailing work also completed followed by new subfloor and floors are now being framed with new walls.

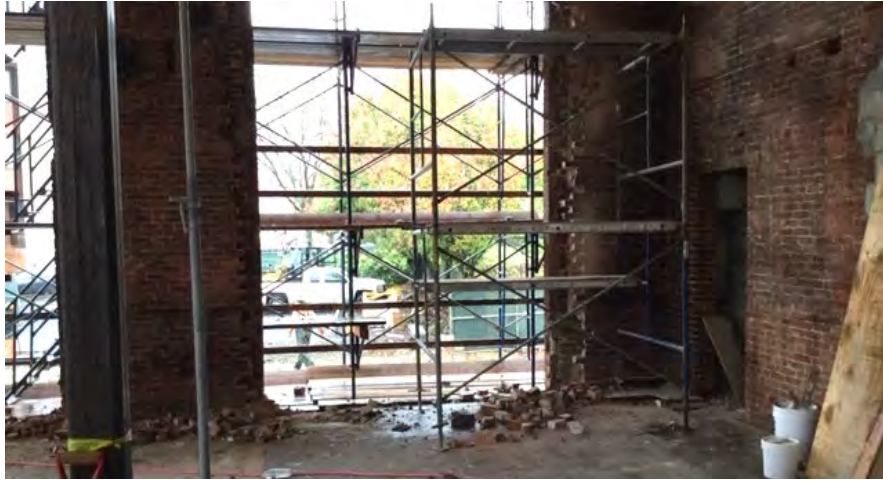
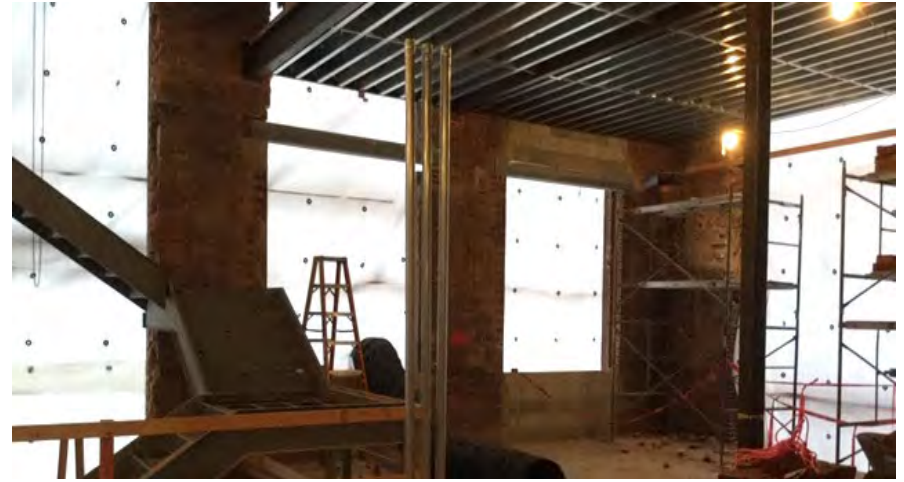
1879 UNKNOWN INTERIOR MASONRY RESTORATION WORK

- Work shown here was discovered through demolition finding the poor conditions of the mortar and brick once uncovered. The jambs of these openings are structural and need to support the wood blocking and new windows that are in some cases up to 11+’ wide and 33’ tall.
- Jambs need to be demolished and re-installed up to an average of 18” wide by the full height of the openings on 9 openings between the 1st and 3rd floor.
- This work is now completed as well as blocking for windows and Intus Window systems will be started in this area before the end of the year.

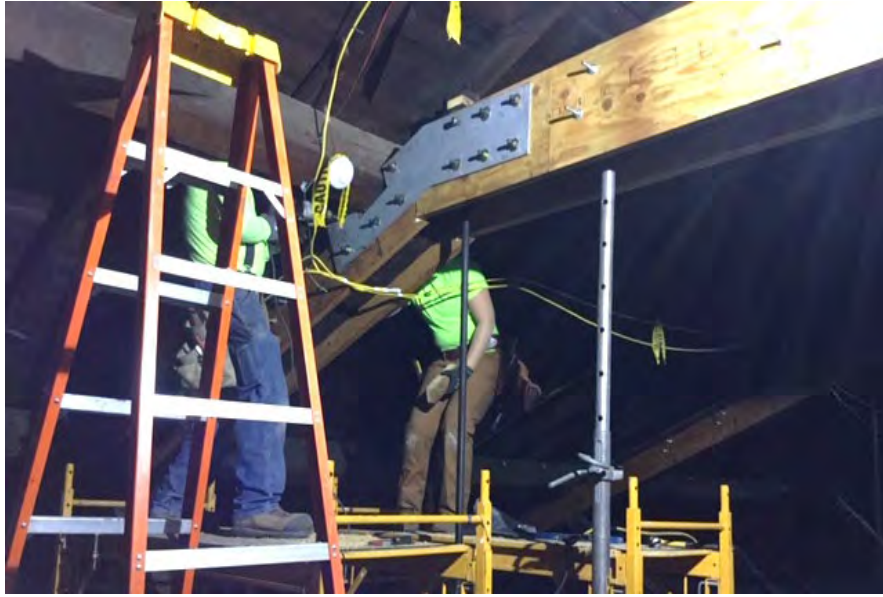
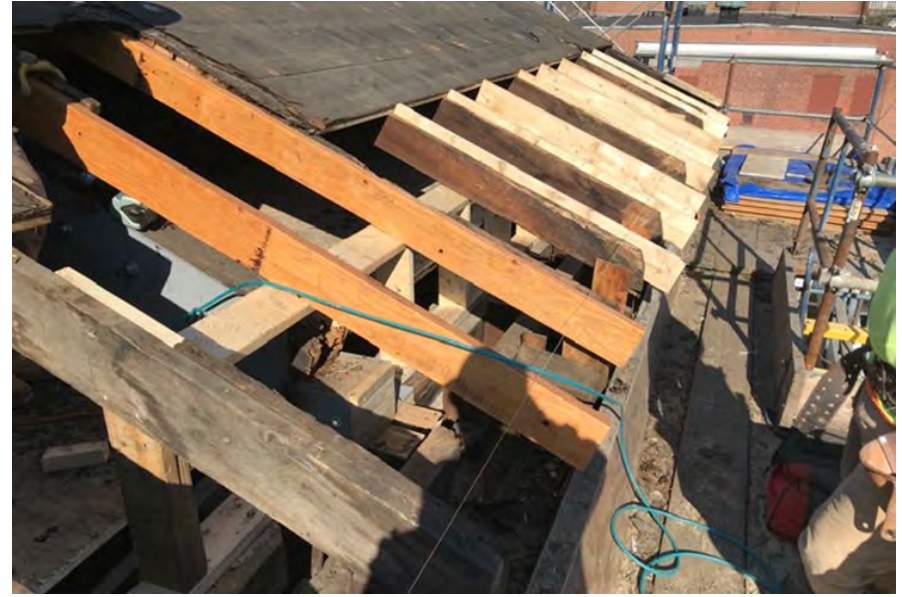
RIDGE AND EAVE LINE ADDED REPAIRS

- At ridge line we had to jack up ridge with supported truss below on the front 32 feet of the building and install a new ridge beam that would be supported by posts off of the newly sistered top chords of the front 2 trusses. Gussets were also added to bolster these connections.
- At the eave line we found far more infiltration that needed to be addressed as well as alignment issues which were corrected as shown in photos 2 and 3.

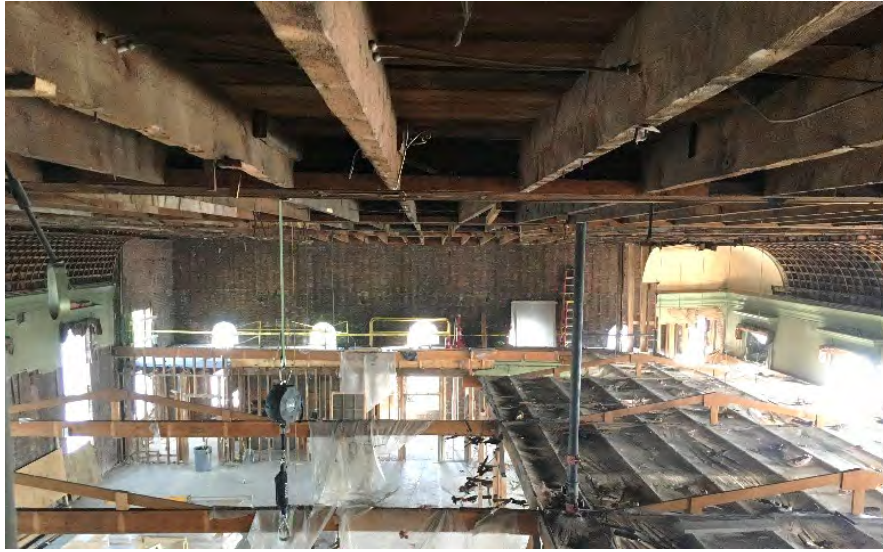
TRUSS REPAIRS

- 1st photo shows trusses as they were found upon starting project with the 11”+ failure
- 2nd photo shows the corrected alignment with false work in place.
- As of Thursday 11/14 the false work was being removed and the only movement that was recorded was less than an 1/8” from corrected elevation showing the repair work to the roof and truss system is a success.

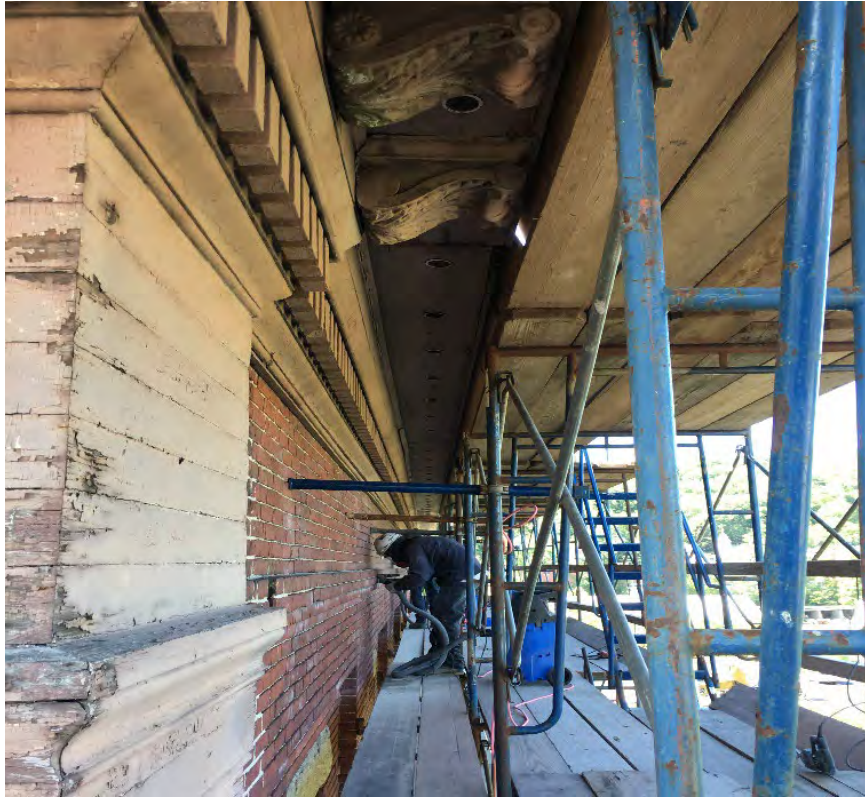
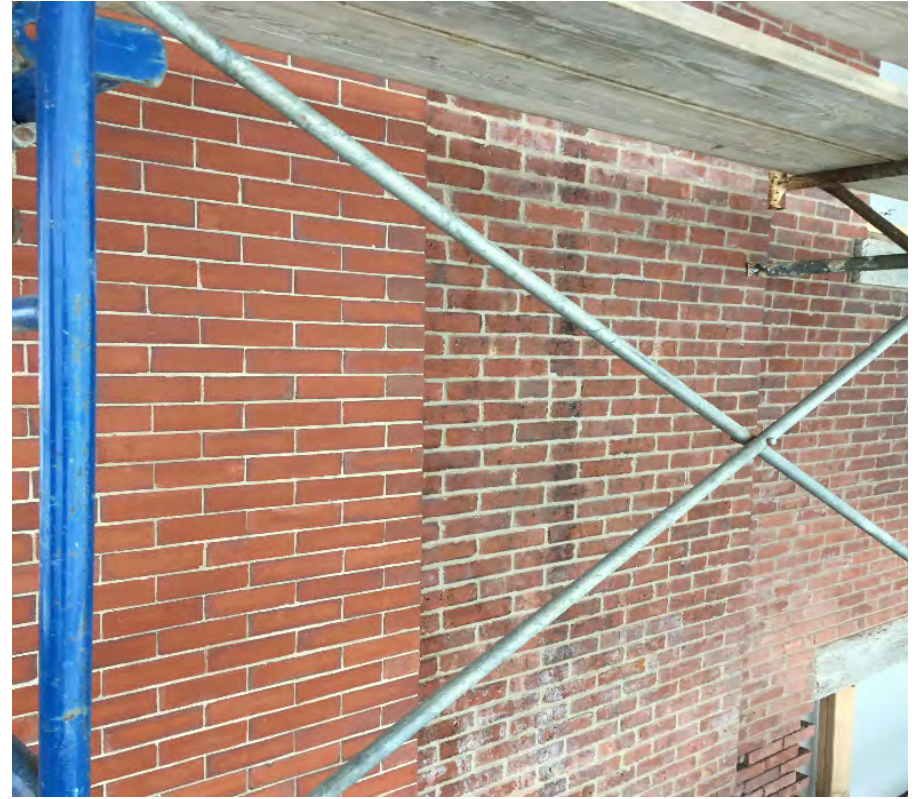
FAÇADE RESTORATION

Masonry: cleaning, repointing, replacement of cracked and damaged units.
