Strategic Facilities Planning Study

January 2016

City of Fitchburg
MASSACHUSETTS

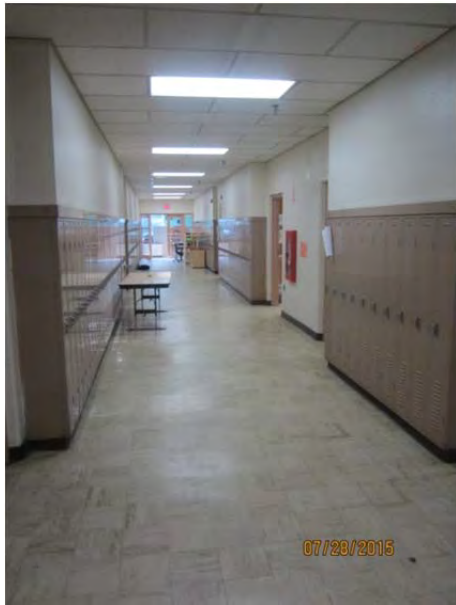
ACCESSIBILITY: The current building is separated into 3 main areas; a 1-story core area, a 2-story plus partial basement NE classroom wing, and a 1-story SW classroom wing. It does not have an elevator and is generally inaccessible except for the core area. The existing ramp between the core area and NE wing appears to exceed the allowable slope considerably and lacks required handrails. Stair handrails typically lack required extensions at top and bottom of stair runs; guards exceed the allowable open space. Toilet room and door maneuvering clearances as well as finish hardware are not in compliance with current requirements.

RATING: POOR

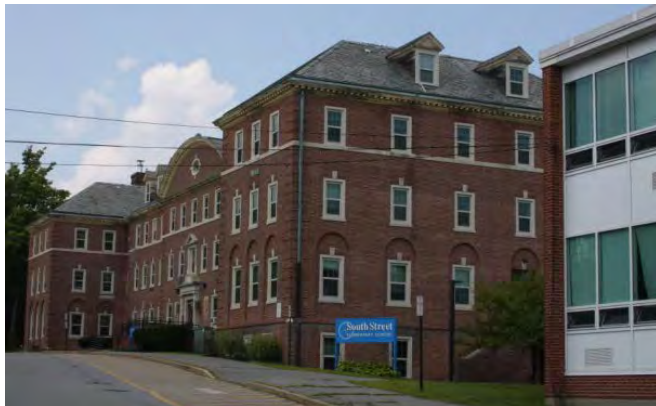
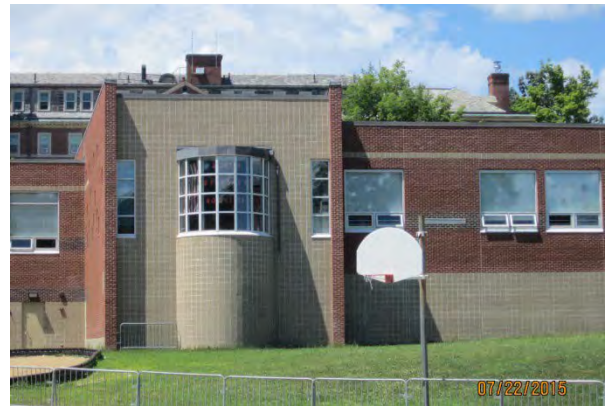
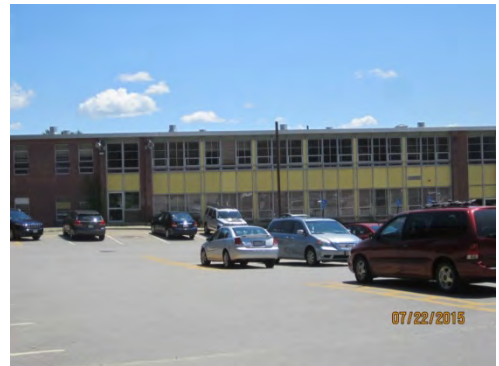
SITE: The majority of school buses do not actually enter the site; they queue along Fairbanks Street, a residential public way to the north of the school property site. In the morning, bused students enter the unoccupied North building and pass through the gym, 2nd floor corridor and down the south stairwell before arriving at the East building lobby area; the reverse occurs in the afternoon. 3-4 private charter buses enter at the South Street entrance and bear left to line up in front of the West building, exiting back to South Street across from Ellis Street.

Vans transporting special education students also enter here to access the East building main entrance. Parents picking up or dropping off students enter at the South Street entrance as well, but bear right past the South building. Parents then queue in 5 marked lanes at the rear paved play area, and exit the site via Munroe Street. 50-60 student walkers cross South Street near Ellis Street. School staff/faculty, District administrators, and visitors all share available parking along South Street, in the NW upper lot and along the east edge of the SE paved play area. The convergence of pedestrian/vehicular traffic (i.e. at the narrow driveway opening between the West building and adjacent retaining wall) and the generally narrow/circuitous vehicular circulation were identified as concerns by both school administrators and public safety officials. The queuing of buses along a public way, blocking access to private residences in the morning and afternoon, was also recognized as an issue.

RATING: POOR

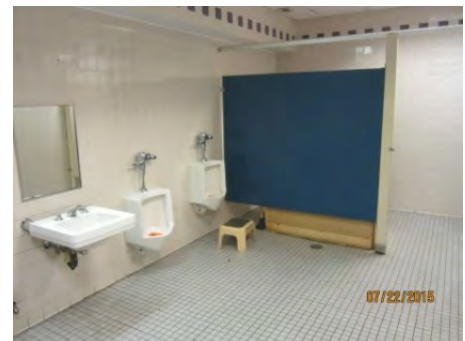
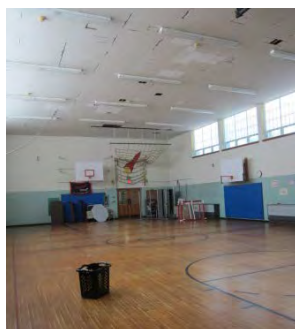
ACCESSIBILITY: Currently there are four distinctly separate buildings; West (containing District offices), North (unoccupied), South and East. Although all four buildings are physically connected in some way, not every space or level is accessible. It is probable that even a relatively small scope of work will trigger the requirement for full compliance with 521 CMR accessibility regulations. Wheelchair lifts have been installed in some locations, however their use is restricted in terms of accessibility regulations (i.e. they can be used to provide access to a performing area/stage or to an area, such as the Nurse's suite in the West Building, where the vertical level change is less than a full floor and a ramp is not feasible; they cannot be used as a blanket substitution for an elevator).

The existing West Building elevator appears too small to meet current accessibility requirements. Except for the East Building, stairways (including tread/risers, guards and handrails), toilet room and door maneuvering clearances as well as finish hardware are generally not in compliance with current requirements.

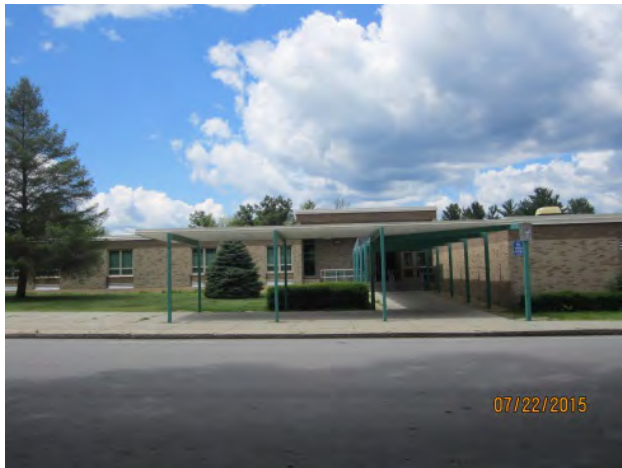
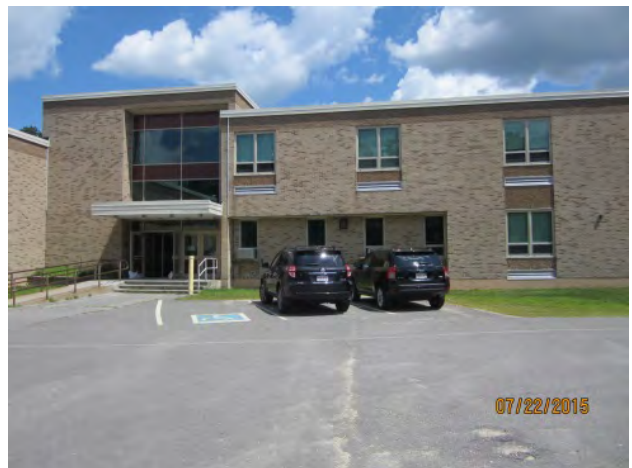
SITE: School buses enter the site from Reingold Avenue and utilize the front (east) of the building for student drop-off and pickup. Parents picking up or dropping off students enter the same way but queue around the large paved playground to the north of the building. Despite the entrance canopy at the front of the building, the main entry is actually at the rear (west) lower level cul-de-sac; however the driveway on that side is too narrow for two cars to pass simultaneously. School staff/faculty park in the small lot near the upper level entry; LPA was told that 10-15 additional spaces are needed. Currently there is access to only about 70-75% of the building perimeter. A vehicular connection to Depot Street (to the west) was studied but rejected due to topography and regulatory issues. There is an existing Little League baseball field, along with a large wooded area, to the north of the building.

RATING: FAIR

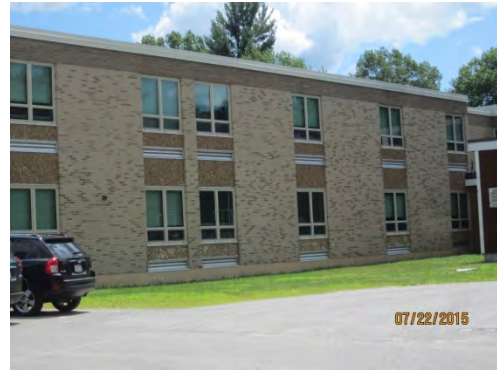
West Building: The roofing is relatively recent (2010) single-ply membrane roofing system. Windows, storefront and exterior entries were replaced in or about 2012 with new aluminum projected windows/storefronts/entries with insulating glass. Exterior walls, except for modular construction, are brick masonry with exposed aggregate concrete panels and aluminum louvers at windows. The masonry appears generally to be in good condition.

RATING: GOOD

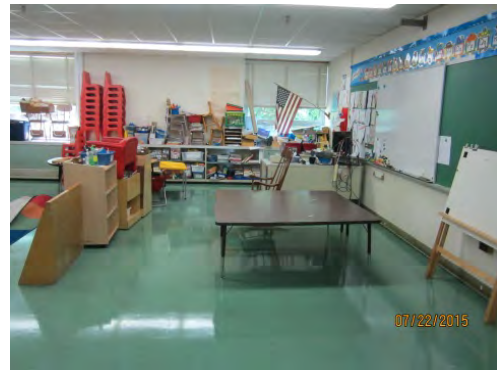
The Media Center has carpet flooring that is in poor condition due to moisture infiltration. There are no Corridor lockers; Classrooms have built-in closets with wood doors.

RATING: FAIR

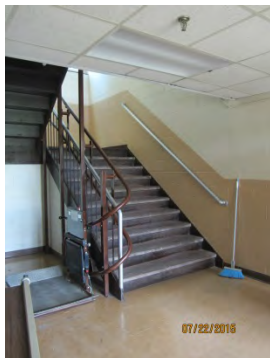
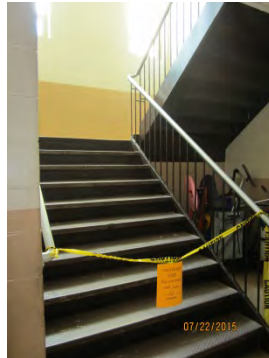
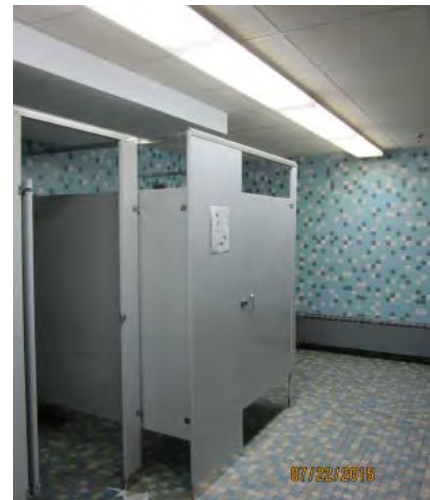
full compliance with 521 CMR accessibility regulations. Stairways (including tread/risers, guards and handrails), door maneuvering clearances and finish hardware do not fully comply with current regulations.

RATING: POOR

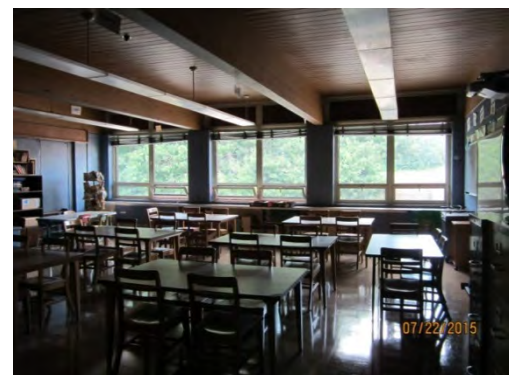
floors, base and walls; toilet compartment partitions are painted steel. Corridor lockers are painted steel with hinged book compartments over single doors. Interior glazing is typically diamond-pattern wired glass.

RATING: POOR

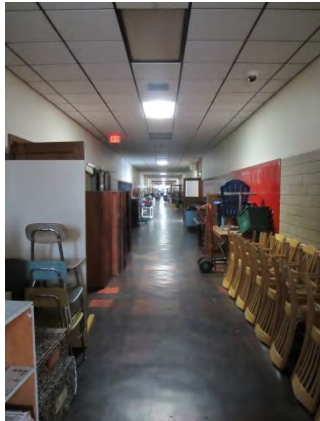
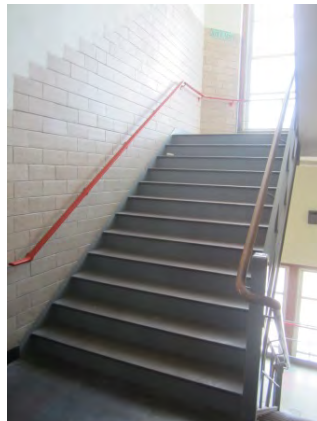
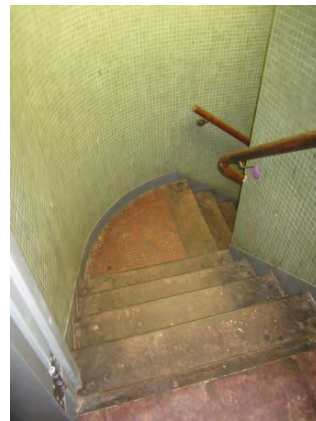
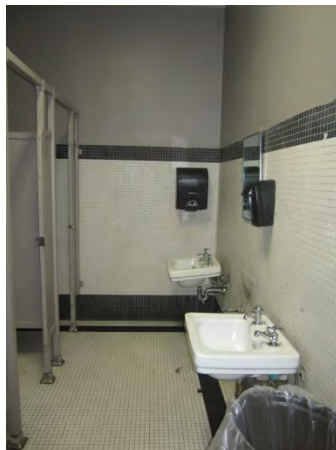
ACCESSIBILITY: The current building floor levels are accessible via elevator; however only the Media Center building entry is accessible. It is unknown whether the existing elevator meets current size requirements. The other main building entries are inaccessible due to their being at half-levels. Wood stair handrails typically lack required extensions at top and bottom of stair runs; stair guards exceed the allowable open space. Toilet room and door maneuvering clearances as well as finish hardware are not in compliance with current requirements.

RATING: POOR

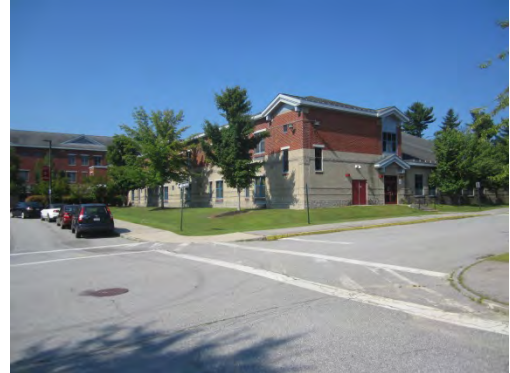
EXTERIOR ENVELOPE: Roofing consists of low slope single-ply membrane system and asphalt shingle systems. Windows, doors and storefront are aluminum with insulating glass. Exterior walls are predominantly brick and split-face CMU masonry with some composite metal paneling. Generally the exterior envelope, given its recent vintage, is in good condition. However in places the masonry, especially the CMU due to its' porosity, has been stained by water running off of metal flashings and low roofs. Additionally, LPA was told that there have been some roof leaks, and that gaps in the air/vapor and thermal insulation barriers have been found. These conditions have reportedly been addressed as they were uncovered.

RATING: GOOD

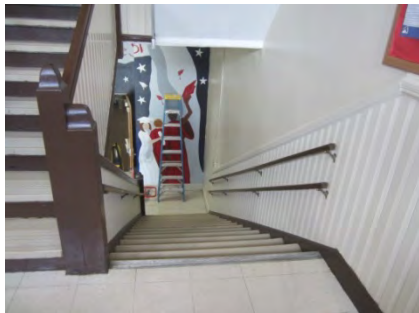
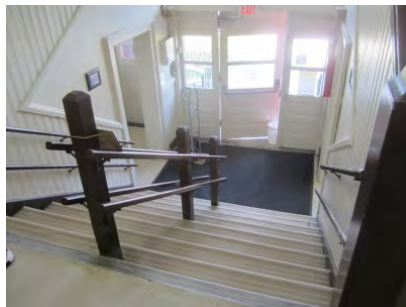
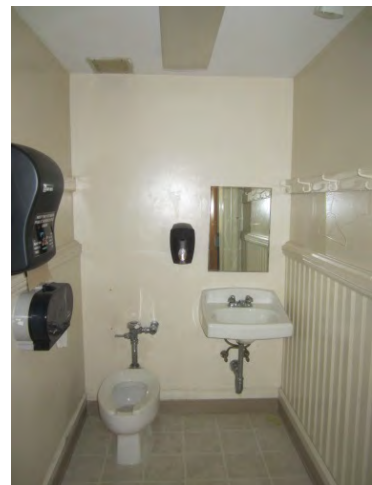
ACCESSIBILITY: The building does not have an elevator or lift and is generally inaccessible. Wood stair handrails typically lack required extensions at top and bottom of stair runs. Toilet room and door maneuvering clearances as well as finish hardware are not in compliance with current requirements.
RATING: POOR
